SIMPLIFIED DESCRIPTION OF TYPICAL BUILDINGS

E.8.2 Typical Types of Earthquake Damage

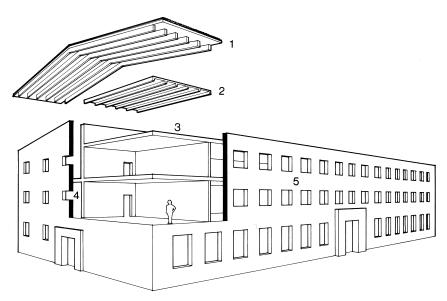
- Roof/floor span systems:
- heavy timber rafter roof
 concrete joist and slab
- 3. concrete flat slab

- Wall system:
- 4. interior and exterior concrete bearing walls
- large window penetrations of school and hospital buildings

Figure E-30 Drawing of concrete shear-wall building.

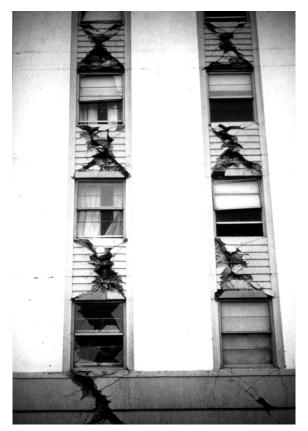
Figure E-31 Tall concrete shear-wall building: walls connected by damaged spandrel beams.

- 1. During large seismic events, shear cracking and distress can occur around openings in concrete shear walls and in spandrel beams and link beams between shear walls (See Figures E-31 and E-32.)
- 2. Shear failure can occur at wall construction joints usually at a load level below the expected capacity.
- 3. Bending failures can result from insufficient vertical chord steel and insufficient lap lengths at the ends of the walls.

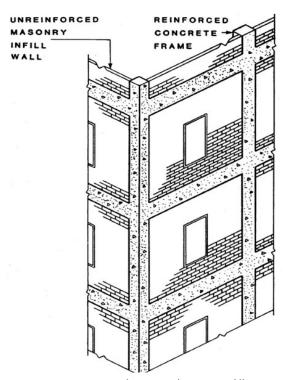
Figure E-33 Concrete frame with URM infill.

These buildings (Figures E-33 and E-34) have been, and continue to be, built in regions where unreinforced masonry (URM) has not been eliminated by code. These buildings were generally built before 1940 in high-seismicity regions and may continue to be built in other regions.

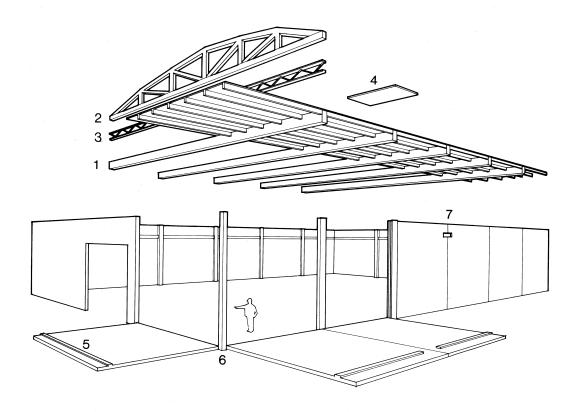
Roof/floor diaphragms:

4. plywood sheathing

- Roof/floor span systems:
- glue liminated beam and joist
 wood truss
- 3. light steel -web joist

Details:

anchor bolted wooden ledger for roof/floor support Wall systems:

- cast-in-place columns-square, "T" shape, and "H" shape
- 7. welded steel plate type panel connection

Figure E-35 Drawing of tilt-up construction typical of the western United States. Tilt-up construction in the eastern United States may incorporate a steel frame.

In traditional tilt-up buildings (Figures E-35 through E-37), concrete wall panels are cast on the ground

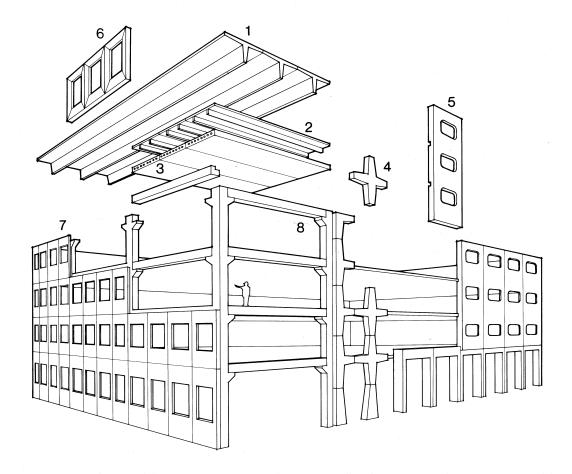
- 1. structural concrete "T" sections
- 2. structural double "T" sections
- 3. hollow core concrete slab

- 4. load-bearing frame components (cross)
- 5. multi-story load-bearing panels

- 6. precast concrete panels
- 7. metal, glass, or stone panels

8. precast column and beams

Figure E-41 Drawing of precast concrete frame building.

Precast concrete frame construction, first developed in the 1930s, was not widely used until the 1960s. The precast frame (Figure E-41) is essentially a post and beam system in concrete where columns, beams and slabs are prefabricated and assembled on site. Various types of members are used. Vertical-load-carrying elements may be Ts, cross shapes, or arches and are often more than one story in height. Beams are often Ts and double Ts, or rectangular sections. Prestressing of the members, including pretensioning and post-tensioning, is often employed. The identification of this structure type cannot rely solely on construction date, although most precast concrete

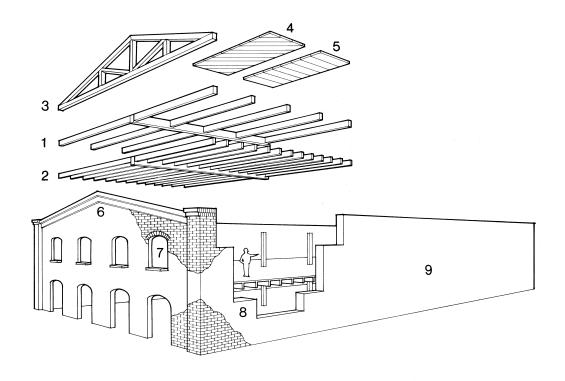
- 1. wood post and beam (heavy timber)
- 2. wood post, beam, and joist (mill construction)
- 3. wood truss-- pitch and curve

- 4. diagonal sheathing
- 5. straight sheathing

- 6. typical unbraced parapet and cornice
- 7. flat arch window opennings

- 8. bearing wall-- four or more wythes of brick
- 9. typical long solid party wall

Figure E-47 Drawing of unreinforced masonry bearing-wall building, 2-story.

Most unreinforced masonry (URM) bearing-wall structures in the western United States (Figures E-47 through E-51) were built before 1934, although this construction type was permitted in some jurisdictions having moderate or high seismicity until the late 1940s or early 1950s (in some jurisdictions URM may still be a common type of construction, even today). These buildings usually range from one to six stories in height and function as commercial, residential, or industrial buildings. The construction varies according to the type of use, although wood floor and roof diaphragms are common. Smaller commercial and residential buildings usually have light wood

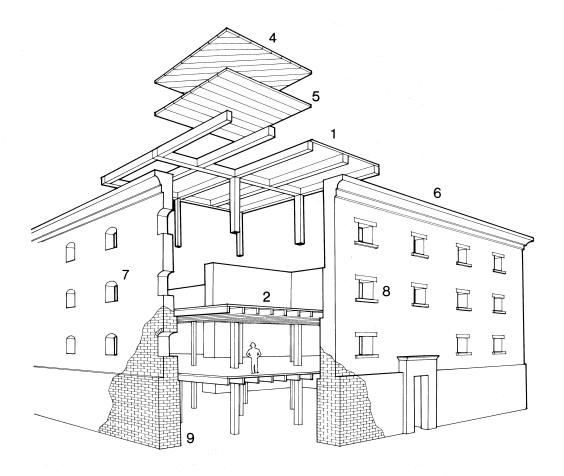
- 1. wood post and beam (heavy timber)
- 2. wood post, beam, and joist (mill construction)
- 3. wood truss-- pitch and curve

- 4. diagonal sheathing
- 5. straight sheathing

- 6. typical unbraced parapet and cornice
- 7. flat arch window opennings
- 8. small window penetrations (if bldg is originally a warehouse)

Figure E-48 Drawing of unreinforced masonry bearing-wall building, 4-story.

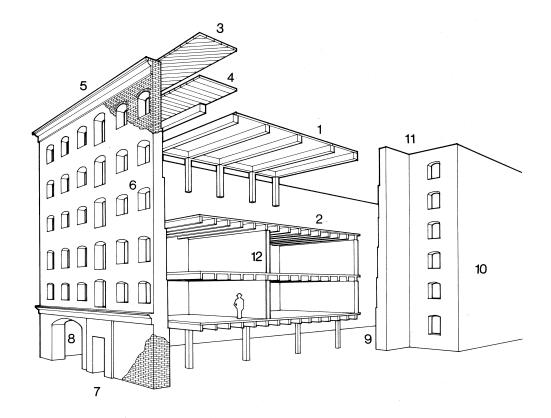
- 1. wood post and beam (heavy timber)
- 2. wood post, beam, and joist (mill construction)

- 3. diagonal sheathing
- 4. straight sheathing

- 5. typical unbraced parapet and cornice
- 6. flat arch window opennings
- 7. typical penetrated facade of residential buildings
- 8. large opennings of ground floor shops

- 9. bearing wall-- four to eight wythes of brick
- 10. typical long solid party wall
- 11. light/ventilation wells in residential bldg
- 12. non-structural wood stud partition walls

Figure E-49 Drawing of unreinforced masonry bearing-wall building, 6-story.

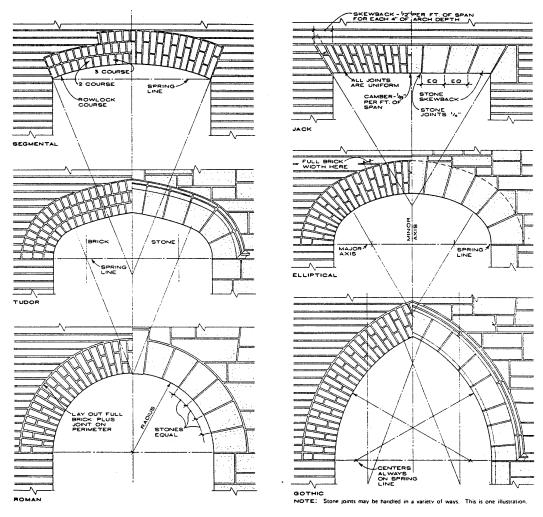
Figure E-52 Drawings of typical window head features in URM bearing-wall buildings.

window heads (see Figure E-52). These arrangements of masonry units function as a header to carry the load above the opening to either side. Although masonry-veneered wood-frame structures may have these features, they are much more widely used in URM bearing-wall structures, as they were the most economical method of spanning over a window opening at the time of construction. Other methods of spanning are also used, including steel and stone lintels, but these methods are generally more costly and usually employed in the front facade only.

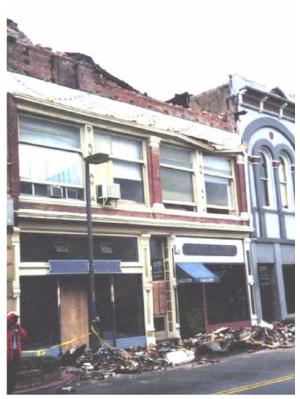
Figure E-53 Parapet failure leaving an uneven roof line, due to inadequate anchorage, 1989 Loma Prieta earthquake.

1. Insufficient Anchorage—Because the walls, parapets, and cornices are not positively anchored to the floors, they tend to fall out. The collapse of bearing walls can lead to major building collapses. Some of these buildings have anchors as a part of the original construction or as a rehabilitation. These older anchors exhibit questionable performance. (See Figure E-53 for parapet damage.)
